Little Deschutes River Restoration and Fish Habitat Enhancement At Crosswater

Jim Ramey CGCS
Crosswater Club
Sunriver, OR

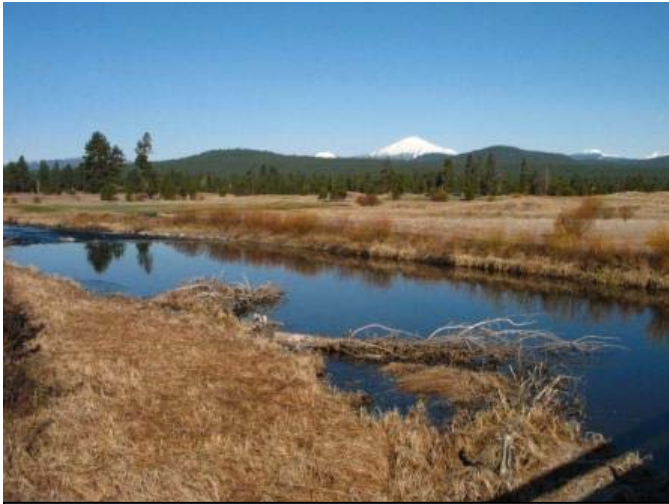
Little Deschutes River at Crosswater as it appeared in April 2007.

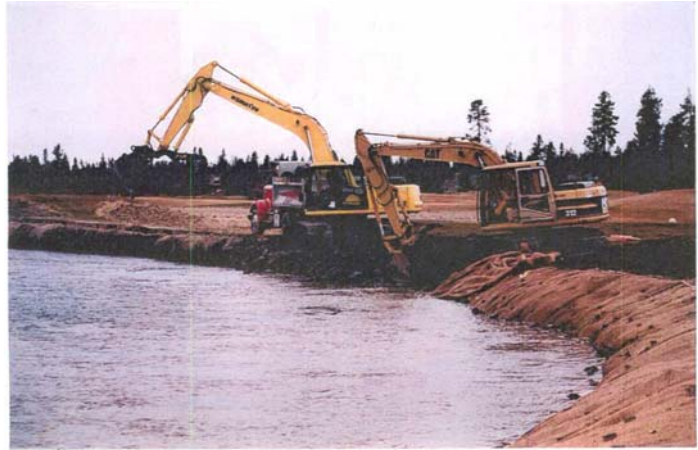
Various stages of the bank stabilization in 1993

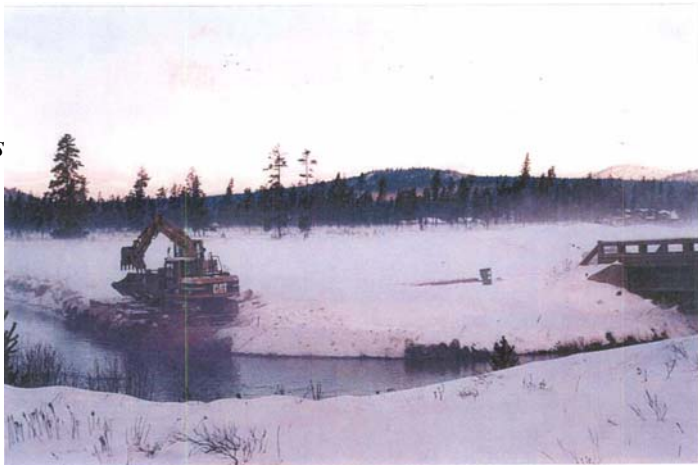
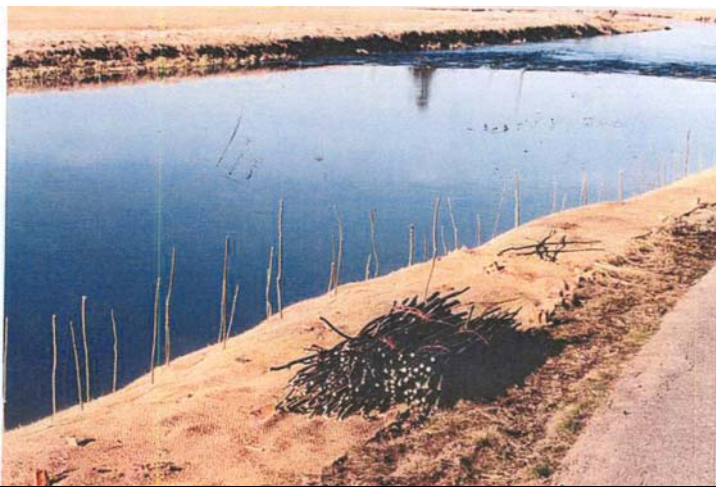
Willow cuttings were used hold and stabilize the bio-degradable jute fabric.

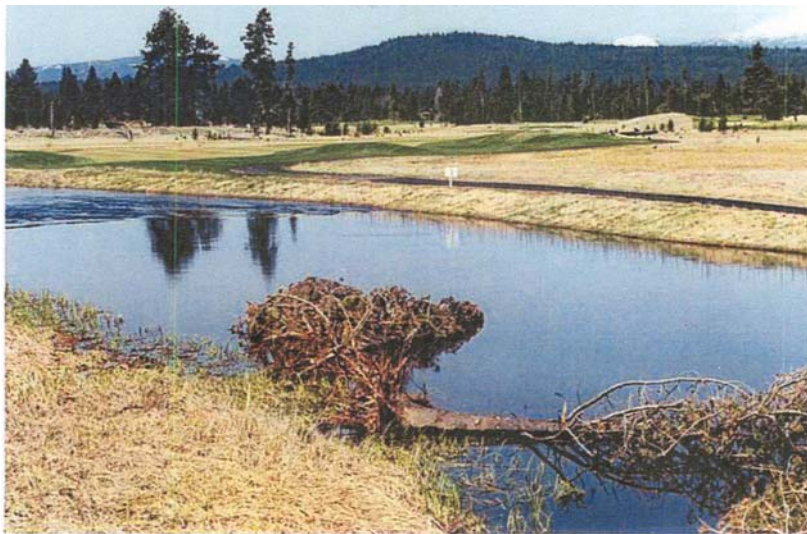
This late 1990's photo matches the introductory photograph in 2007. It shows the completed bank stabilization, dead trees in place, and a created riffle on the top left side.
